OPCW

S/1731/2019

NOTE BY THE TECHNICAL SECRETARIAT

**REPORT OF THE FACT-FINDING MISSION REGARDING THE INCIDENT
OF ALLEGED USE OF TOXIC CHEMICALS AS A WEAPON
IN DOUMA, SYRIAN ARAB REPUBLIC, ON 7 APRIL 2018**

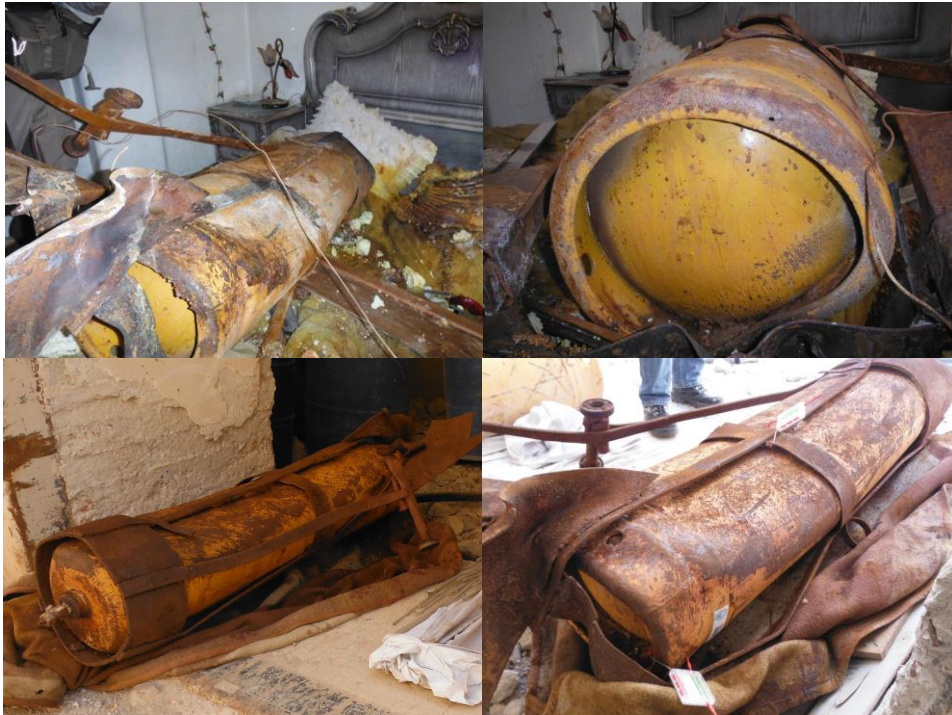
FIGURE 14: DAMAGE OBSERVED ON THE CYLINDER

- 8.35 In a similar manner, the FFM assessed the consistency between the structural damage appearing on the cylinder against the structural damage to the rebar-reinforced

concrete roof through which the cylinder allegedly traversed. Results are presented in Figures 13 and 14.

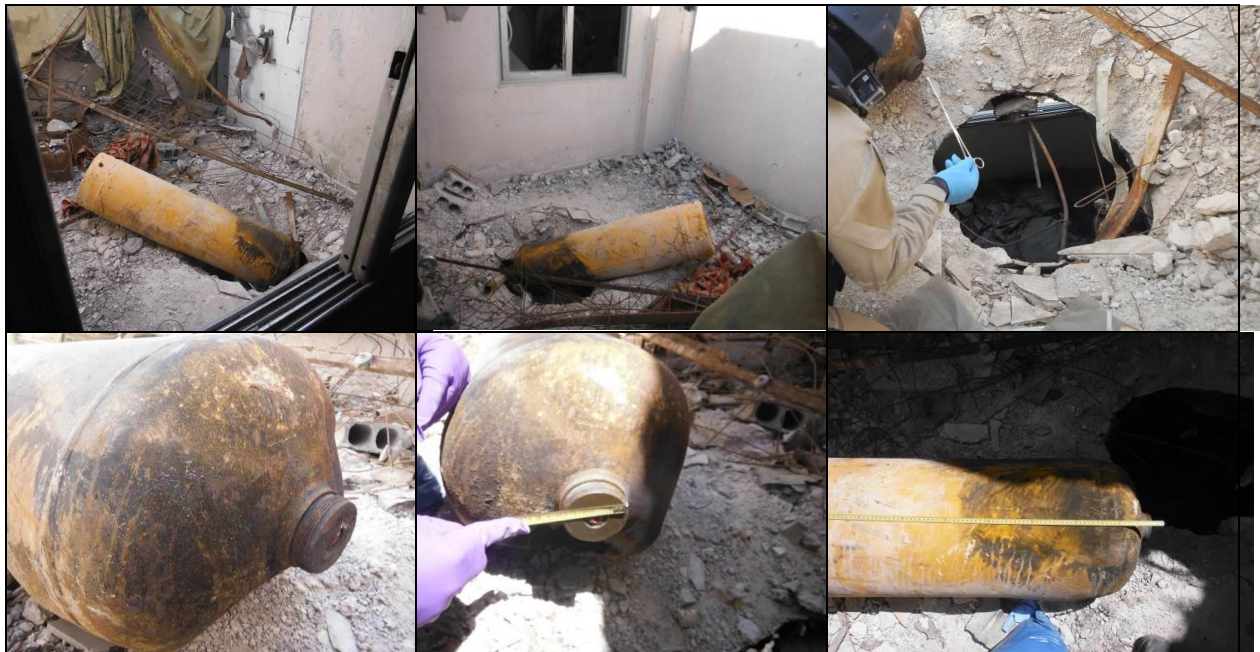
FIGURE A.6.1 PHOTOS OF TERRACE, CRATER, AND ROOM BENEATH

3. The aperture observed was circular in shape with approximately 45 degrees angular edges.
4. The mangled ironwork present on the patio indicated that there would have been a metallic frame and mesh covering it at one stage, though it was not clear whether this would have been present at the time of the alleged incident or had been demolished prior to that. The visual damage on the body of the cylinder indicates that the lateral aspect of the cylinder did not slide on the mesh but it hit perpendicularly.

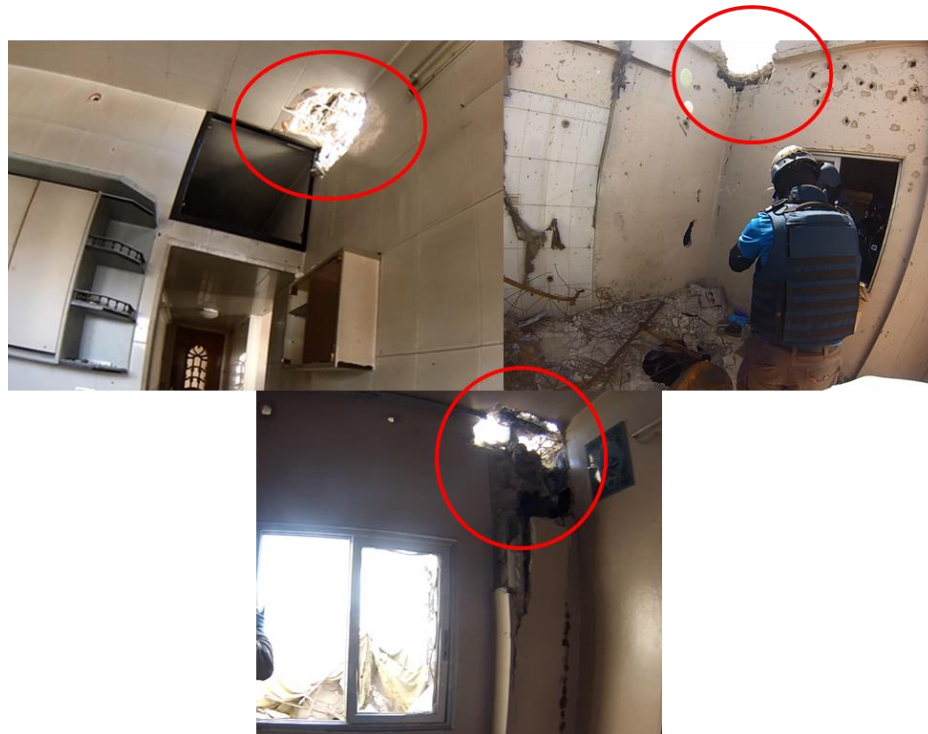
FIGURE A.6.4 DAMAGE ABOVE THE CRATER OBSERVED FROM DIFFERENT ANGLES

6. The team was not able to climb on to the top of the building due to the security restrictions, but was able to observe damage in the corner of the balcony location above the crater.

7. Observing the damage on the roof above the crater, the experts were able to provide an explanation of the cylinder not penetrating completely through the aperture. It can be seen that there was a large impact on the roof and walls above the balcony. The impact would decrease the velocity of the falling cylinder and changed its trajectory while hitting the concrete floor of the balcony causing a hole in it, but without sufficient energy to fall through it.

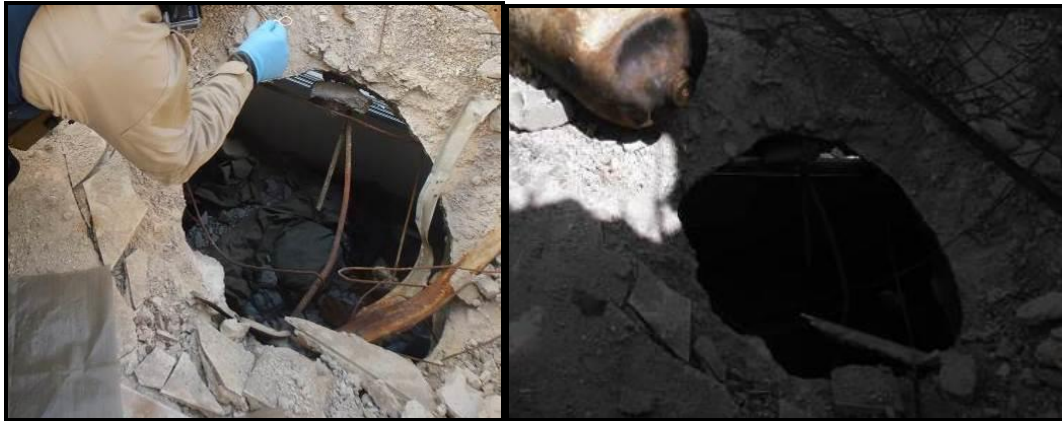
FIGURE A.6.8 CRATER AS SEEN BY FFM INSPECTORS

8. The FFM analysed the damage on the rooftop terrace and below the crater in order to determine if it had been created by an explosive device. However, this hypothesis is unlikely given the absence of primary and secondary fragmentation characteristic of an explosion that may have created the crater and the damage surrounding it.
9. The FFM team noted the blackening of the ceiling and the rim of the aperture from the room immediately below the point of impact (see photo above). It also noted the blackened sooty walls in the corner of the room, as well as what appeared to be the ashen remnants of a small fire. One interviewed witness stated that a fire had been lit in the room after the alleged incident, reportedly to detoxify it of the alleged chemical.

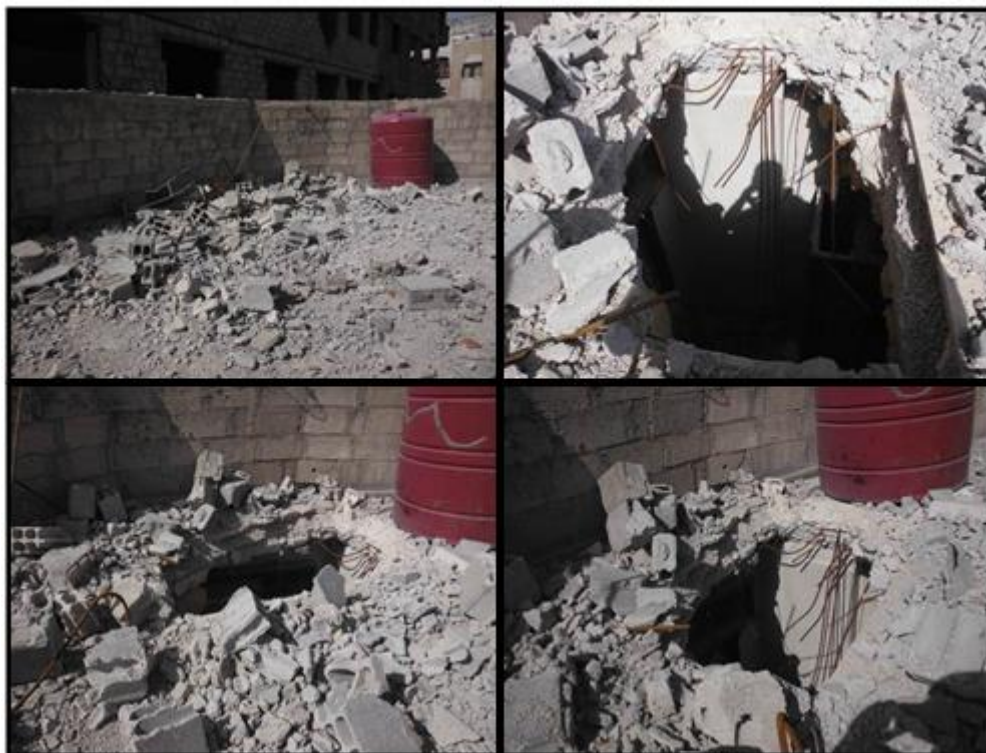
FIGURE A.7.4 CRATER ON THE ROOF OF LOCATION 4

The aperture was located close to a surrounding wall and next to the water tank with approximate dimensions of 166 x 105 cm. The distance from the adjacent building varies between 230 cm and 250 cm.

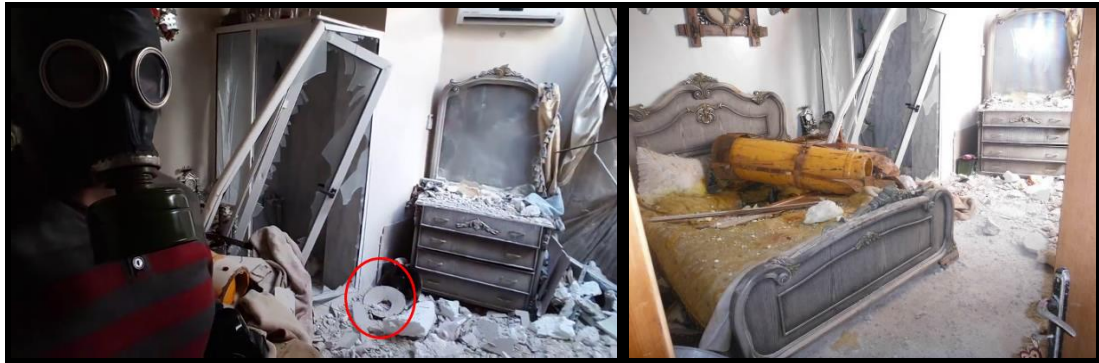
FIGURE A.7.9 FUNNEL CAP

- The bedside lamp on the right side (towards the window) had been moved and was also missing in some photos.
- The FFM team observed a viscous liquid throughout the room, which was not apparent in videos. The same liquid was observed also before the entrance to the apartment and on disposable gloves present at the location (Annex 5).
- The round object similar to the funnel cap found at Location 2 was seen on the open source video.
