OPCW

S/1731/2019

NOTE BY THE TECHNICAL SECRETARIAT

**REPORT OF THE FACT-FINDING MISSION REGARDING THE INCIDENT
OF ALLEGED USE OF TOXIC CHEMICALS AS A WEAPON
IN DOUMA, SYRIAN ARAB REPUBLIC, ON 7 APRIL 2018**

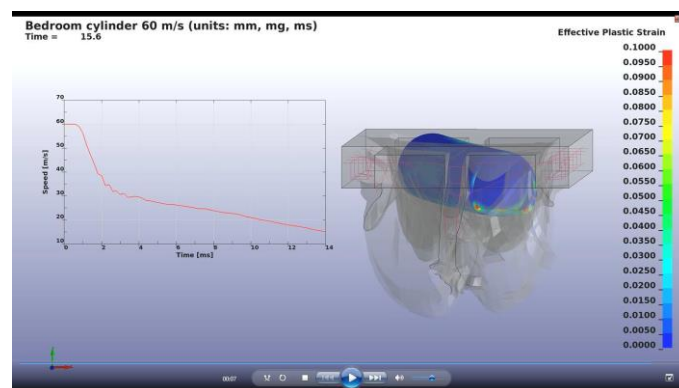
FIGURE 10: COMPUTER MODULATION OF THE APERTURE AND CYLINDER IMPACT

- 8.34 The team consulted experts in mechanical engineering, ballistics and metallurgy to provide qualified, competent assessments of the cylinder trajectory. The results of these assessments indicated that the shape of the aperture produced in the modulation matched the shape and damage observed by the team. The assessments further indicated that, after passing through the ceiling and impacting the floor at lower speed, the cylinder continued altered trajectory, until reaching the position in which it was found.

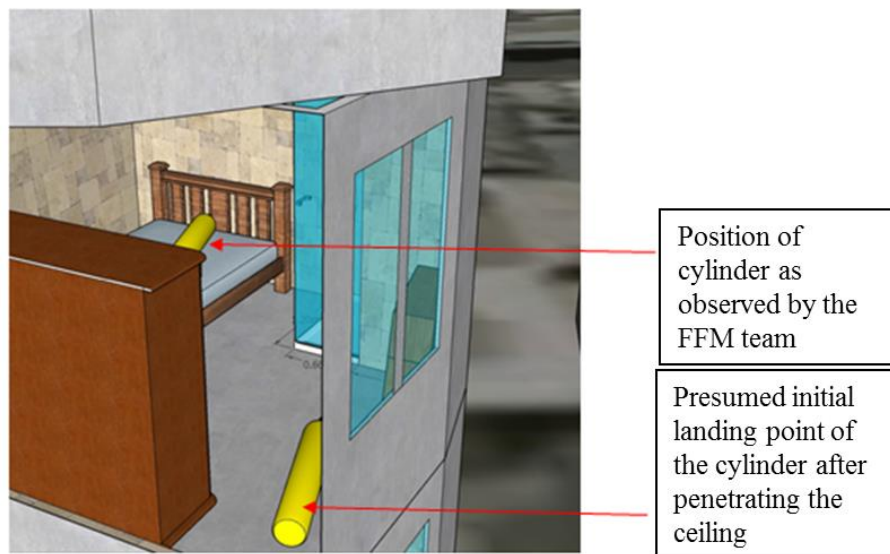
FIGURE 11: VIEW OF THE BEDROOM AND CYLINDER POSITION

- 8.33 From what the team observed, there did not appear to be any leakage from the cylinder at the time the team visited the location. The team noted that a slat of wood was lying under the cylinder on the bed, part of which was taken as a sample. The slat of wood was damp and softened. No chlorine gas was detected in the room by the detection equipment used by the team. The laboratory analysis showed that the wood sample had the highest content of chlorinated organic compounds of all wood samples taken.

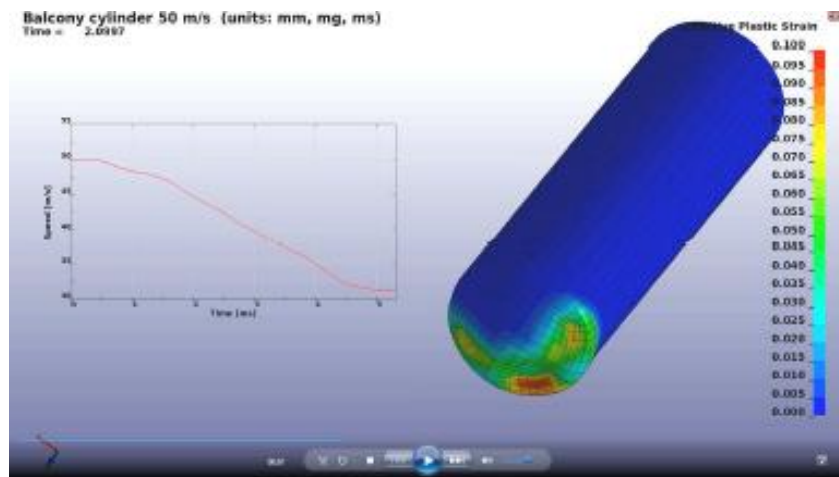
FIGURE A.6.6 CYLINDER FRONT END DEFORMATION IF IMPACTED WITH THE CORNER ON THE ROOF ABOVE THE BALCONY²¹

²¹ The angle shown in figures A.6.6, A.6.7 (a) to (c) are indicative only and not representing actual impact angle.

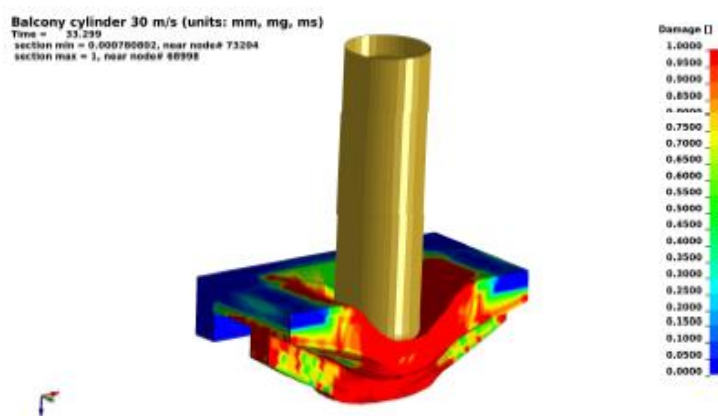
FIGURE A.6.7(b) DAMAGE ON THE CEILING IN THE CASE OF LOW SPEED IMPACT

Red colour indicates zone of complete disintegration

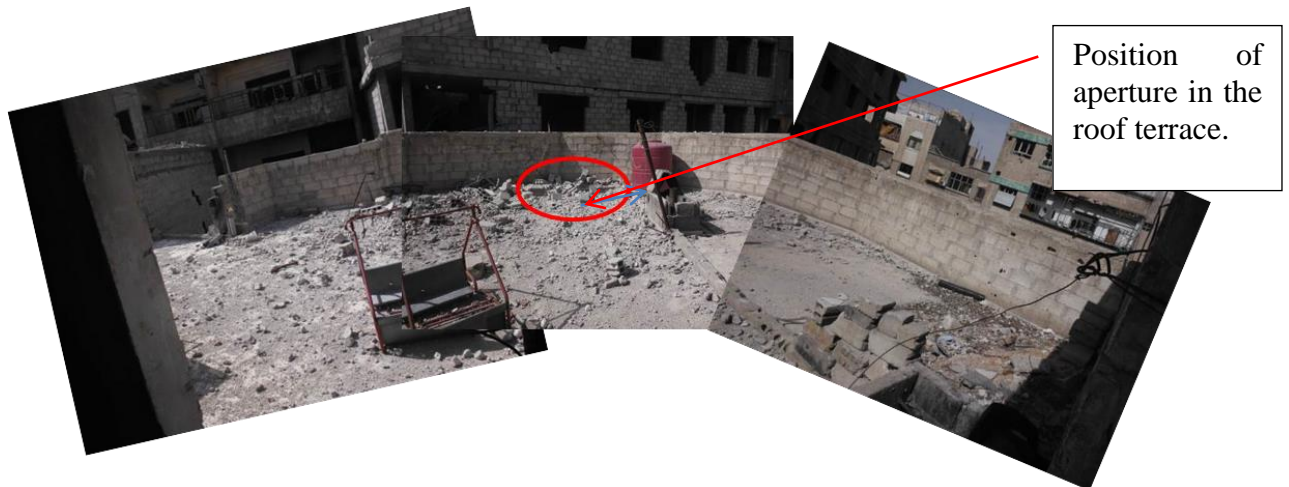
FIGURE A.7.3 ROOF OF LOCATION 4

Area shaded in red marks the roof of Location 4

The aperture was located close to a surrounding wall and next to the water tank with approximate dimensions of 166 x 105 cm. The distance from the adjacent building varies between 230 cm and 250 cm.

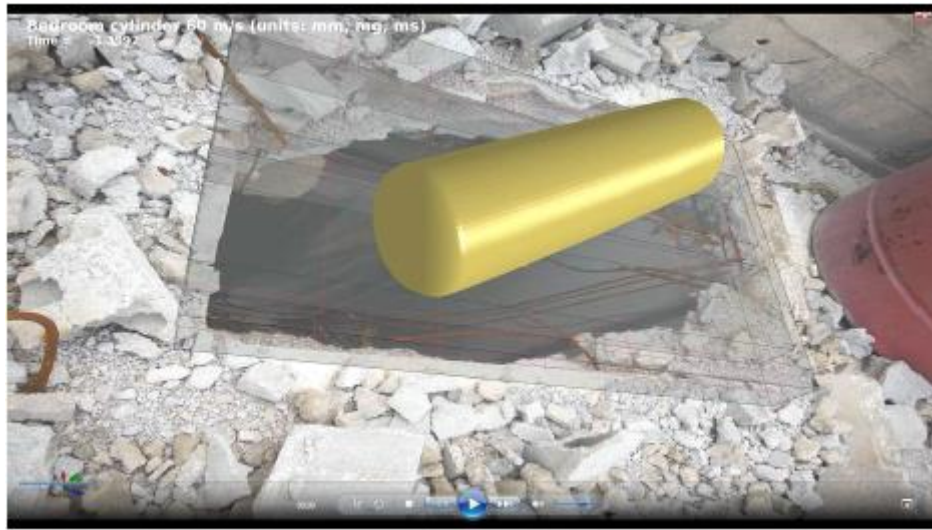
**FIGURE A.7.6 SNAPSHOT OF SIMULATION OF THE POSSIBLE ROOF
CRATER FORMATION**

Considering the proximity of the water tank, the neighbouring buildings, and the surrounding wall adjacent to the hole in the roof, it was concluded that the cylinder impacted the roof as shown in Figure A.7.6. From the shape of the crater and damage on the cylinder, it is likely that the cylinder landed parallel to the ground creating a crater with dimensions of approximately 166 x 105 cm, which is in keeping with the dimensions of cylinder of 140 x 35 cm. It should be noted that the cylinder had an additional structure attached to the body, which is still in line with the dimensions of the crater. The damage observed on site by the FFM team and the possible trajectory of the cylinder based on observed damage and numerical calculations are represented in Figure A.7.7.

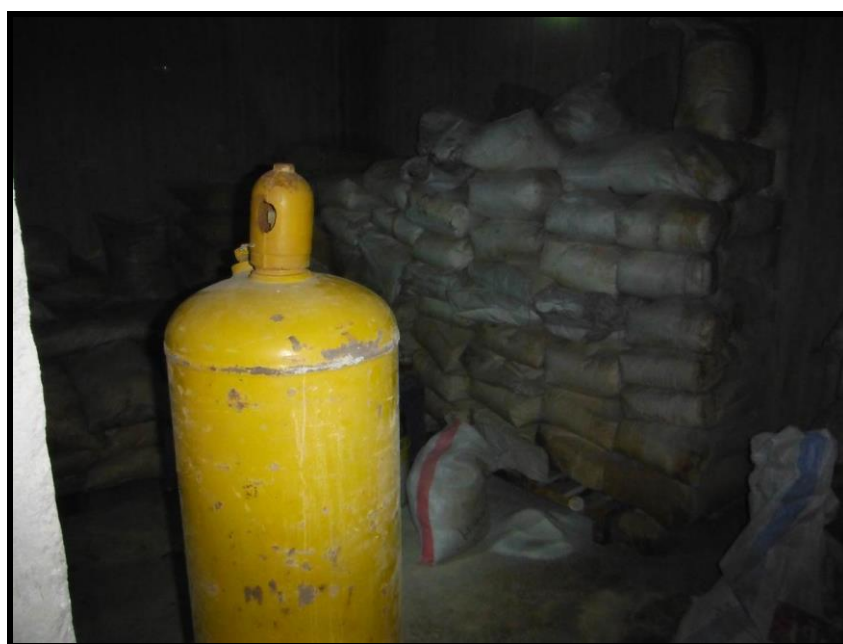
FIGURE A.8.2 CYLINDER OBSERVED BY THE FFM TEAM AT THE WAREHOUSE

7. Although the team confirmed the presence of a yellow cylinder in the warehouse, reported in Note Verbale of the Syrian Arab Republic (Annex 10, point 2) as a chlorine cylinder, due to safety reasons (risk involved in manipulating the valve of the cylinder, see Figure A.8.2) it was not feasible to verify or sample the contents. There were differences in this cylinder compared to those witnessed at Locations 2 and 4. It should be noted that the cylinder was present in its original state and had not been altered. Chlorine gas is generally not a common chlorinating agent in the production of chemical weapons agents, except when used in conjunction with phosphorous trichloride, which was not present. Subsequently, the presence of a cylinder reported as containing chlorine gas is not indicative of the production of explosives.

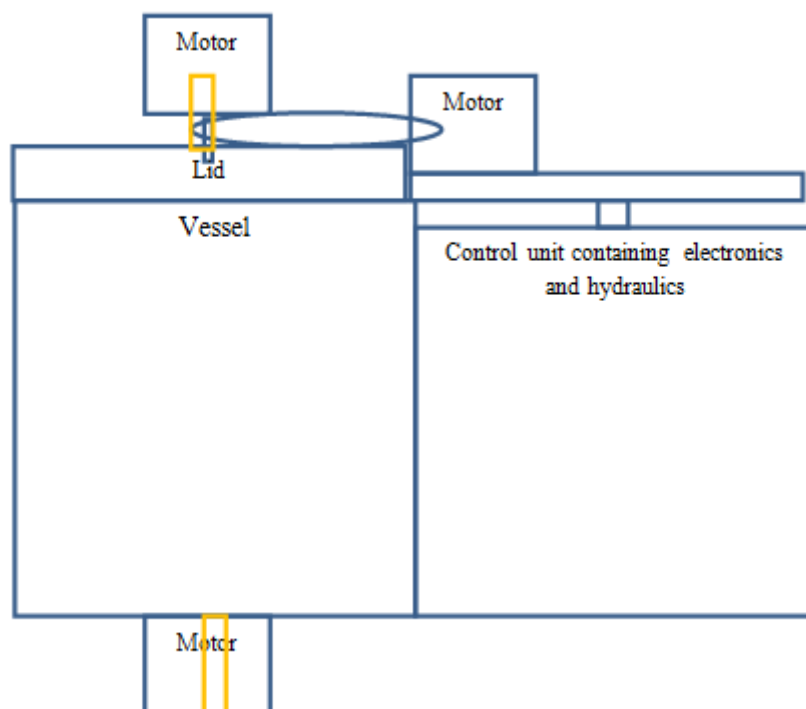
FIGURE A.8.5 SCHEME OF MIXING VESSEL

12. The mixing vessel was of a specific design, and the team considered that these design features did not make the unit particularly suited for chemical synthesis of toxic or any other chemicals. The installation appeared to be a heating and kneading unit that could be used for filling ammunition with liquid explosives or for mixing explosives with additives. Examples would include mixing of TNT with aluminium to produce tritonal, and mixing of RDX with liquid rubber for the production of plastic explosives.
